SERVICE BULLETIN

- Check of the correct assembly of the lateral lower shrouds.

- iFUN 16 SP type wings.

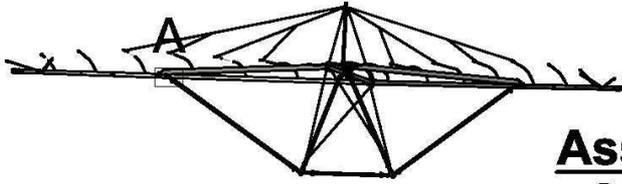
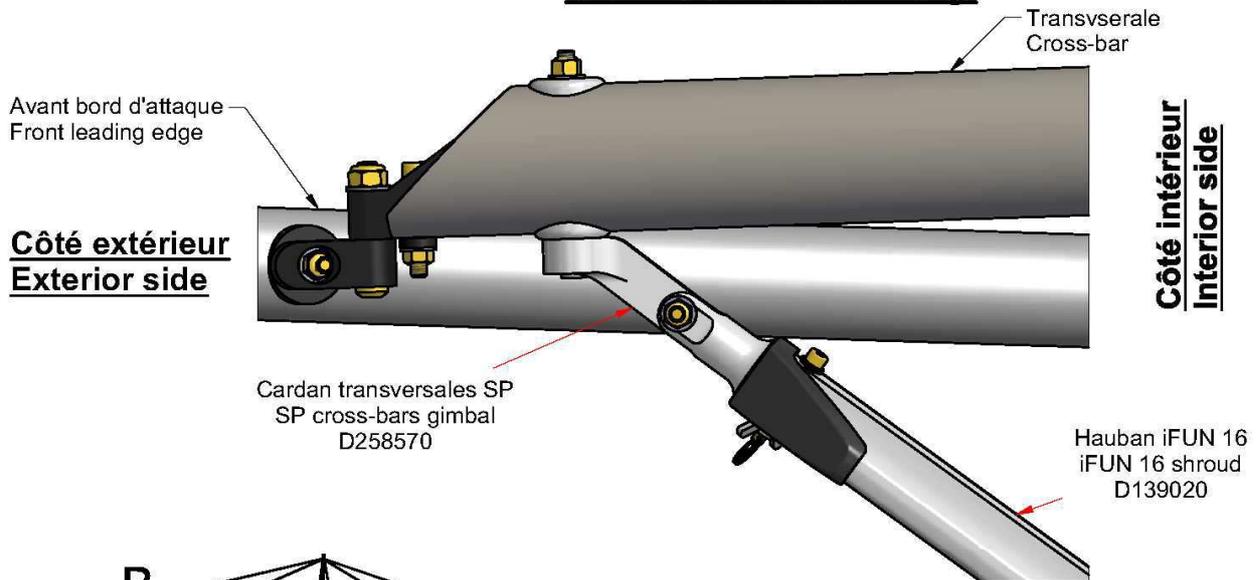
A
Assemblage correct
Correct assembly

- You are therefore asked to check the correct assembly of right and left SP cross-bars gimbals. These parts must imperatively be directed in line with the strut, with their arms directed towards the keel (inward of the wing). If the part forms an angle of about 90° with the strut and therefore the SP cross-bar gimbal arm is directed towards the outside of the wing, it has been mounted in the wrong way **and must be re-assembled to its proper position before any flight !**

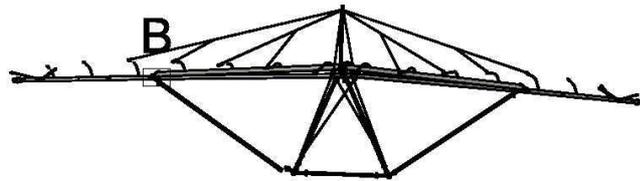
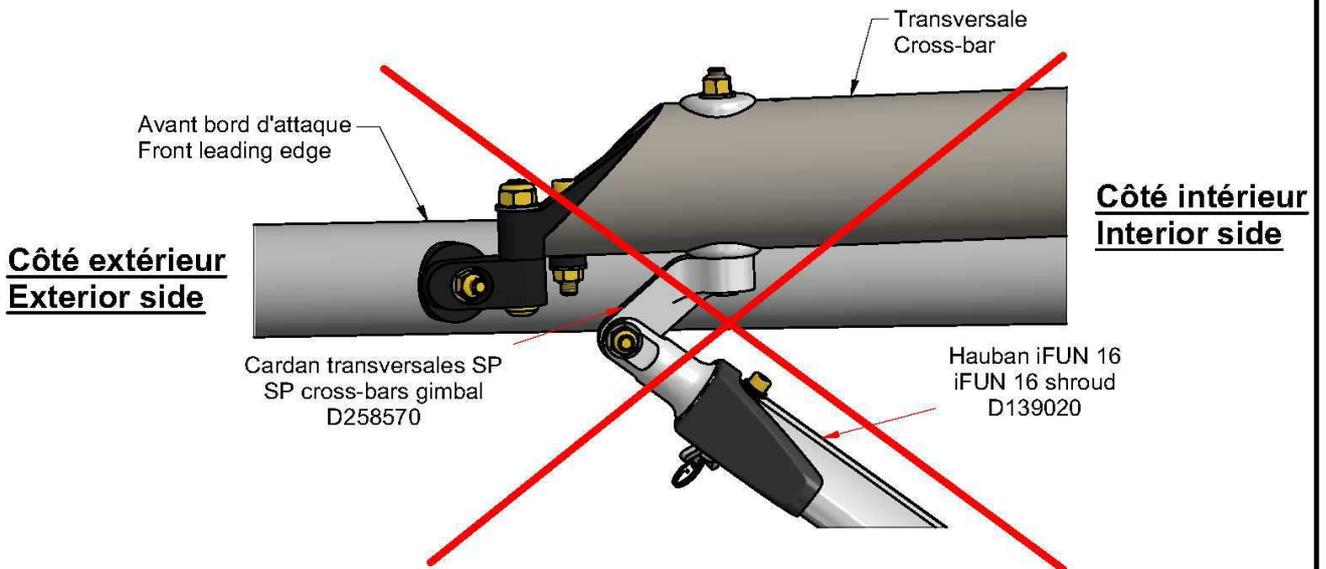
- We just found in our workshops, when a packed iFun 16 SP wing was opened, that an improper assembly can occur if the SP cross-bars gimbal (D258570) connecting the lateral strut with the cross-bar rotates 180° and is then directed towards the outside of the wing. This incorrect installation could cause serious problems because the part is not designed to work this way and the dihedral of the wing is decreased.

B
Assemblage incorrect
Incorrect assembly
