SERVICE BULLETIN

KAIR12002 – Undercarriage Skypper and Tanarg

LANAS 27 June 2012

SUBJECT: Verification of condition of undercarriage tubes Ø25x1.2 securing the connection rod bearing.

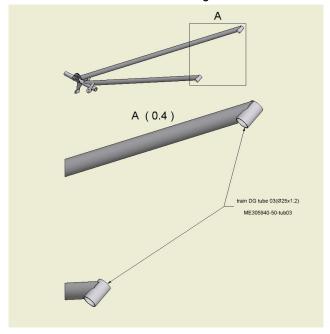
Dessin N°1 / Drawing N°1

Following a defective lot of tubes Ø25x1.2 used only in the manufacture of soldered undercarriages for the Tanarg and Skypper, it is mandatory to check, on the listed trikes, the condition of the soldering of the cylinder at the end of the tubes, this on both of the tubes securing the connection rod bearing (drawing 1). If the welding inside the tube is uninterrupted, there is no problem (photo 1). If the welding is interrupted (photo 2), then the undercarriage must be replaced. In order to continue flying, during the time it takes to receive a replacement part, it is however possible to re-solder (TIG) inside the tube with more metal (photo 3). Finally, if the welding is interrupted, but the welding is maintained by the assembly welding of the main tubes, then it is not necessary to change the undercarriage (photo 4, where the welding is on the opposite side).
