SERVICE BULLETIN

KAIR12005 - 5-Spoke Rim Bearing Assembly

SUBJECT: Verification of condition of rear rim bearing assembly

Aircraft Concerned: Skypper and Tanarg trikes

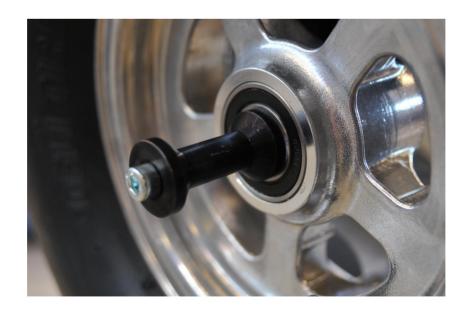
Following a problem that occurred on a trike (incorrect assembly of bearings leading to the break of the blocking screw), it is requested for all owners of concerned trikes to check the assembly of bearings in the 5-spoke rear rims. To do this you must dismount the wheel fairings, then screw back in the screw and aluminum crosspiece (the crosspiece should lightly touch the bearing). You must then turn the wheel quickly and observe if the screw and crosspiece oscillate. If that happens, then the bearing is misplaced in the hub. Flight is prohibited until you contact Air Creation in order to learn the corrective procedure to follow.
